## SITE PRACTICE & TROUBLESHOOTING

# EFFLORESCENCE

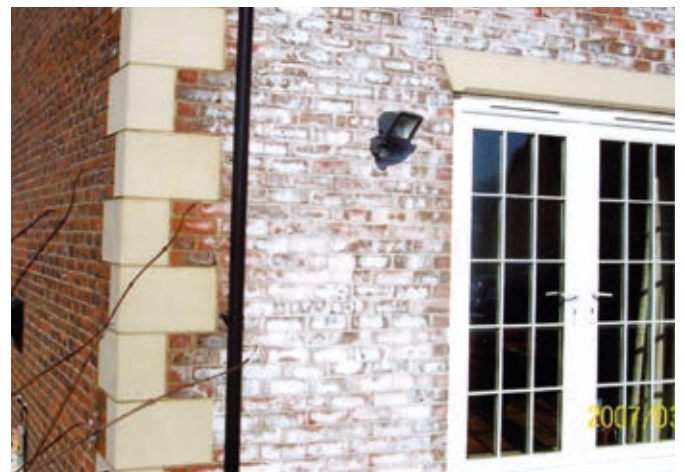
- Bricks should be stacked onto a clean, firm level surface. They should be protected from rain, mud splashes etc. by covering with waterproof sheeting.
- Turn back the scaffolding board closest to the brickwork at all interruptions to construction.

The first 3 to 5 days after laying (dependent on season), brickwork is most vulnerable to the elements as mortar is still undergoing the hardening process. Newly erected masonry should be covered by waterproof sheeting to protect fresh mortar and open cavities to stop masonry becoming saturated. Hessian is not waterproof. Once the structure is watertight, i.e. roof and windows in place, the building can commence the drying process.
