## SITE PRACTICE AND TROUBLESHOOTING DISCOLOURATION OF MASONRY DUE TO SATURATION

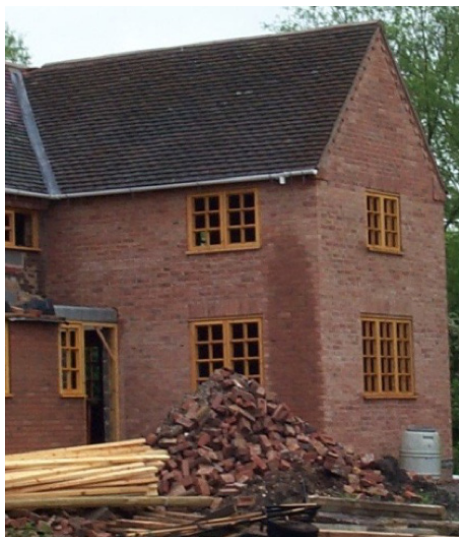
Saturation occurring where downpipes have not been installed.

During rainfall, saturation of masonry can be intensified by other components, for example rain-water outlets prior to the down-pipes being fitted or scaffolding boards adjacent to freshly constructed masonry. The after effects will be localised darkened patches.

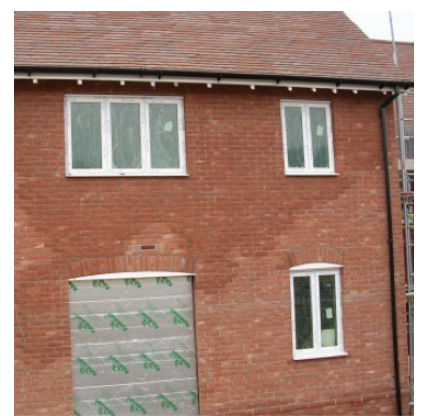
Saturation occurring prior to roof & window placement.
